## **Appendix A**

### **Photograph Log**

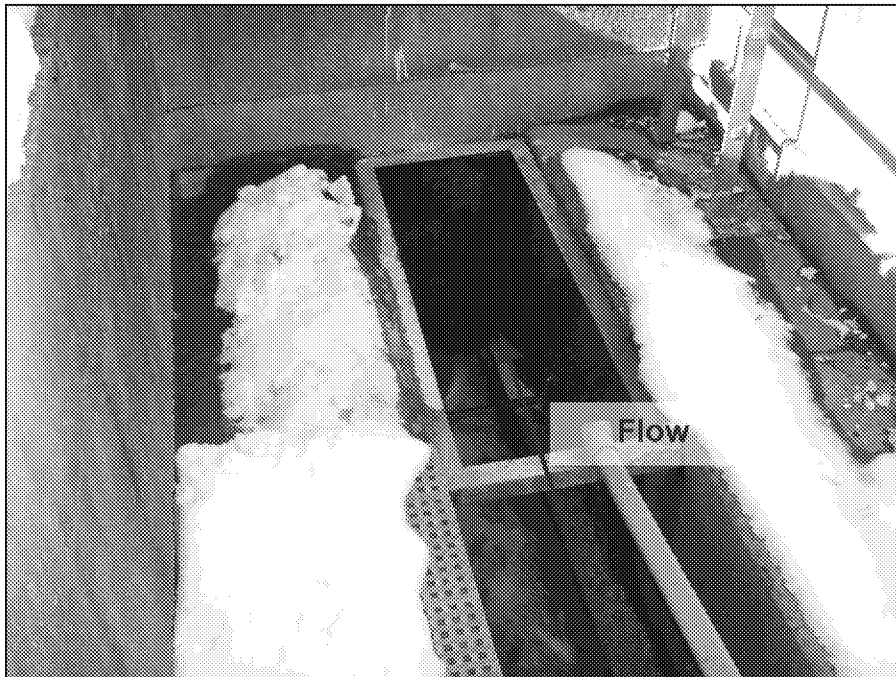
**Photograph 2.** View of the process wastewater collection pit. Wastewater flows into the headworks building from the pit.

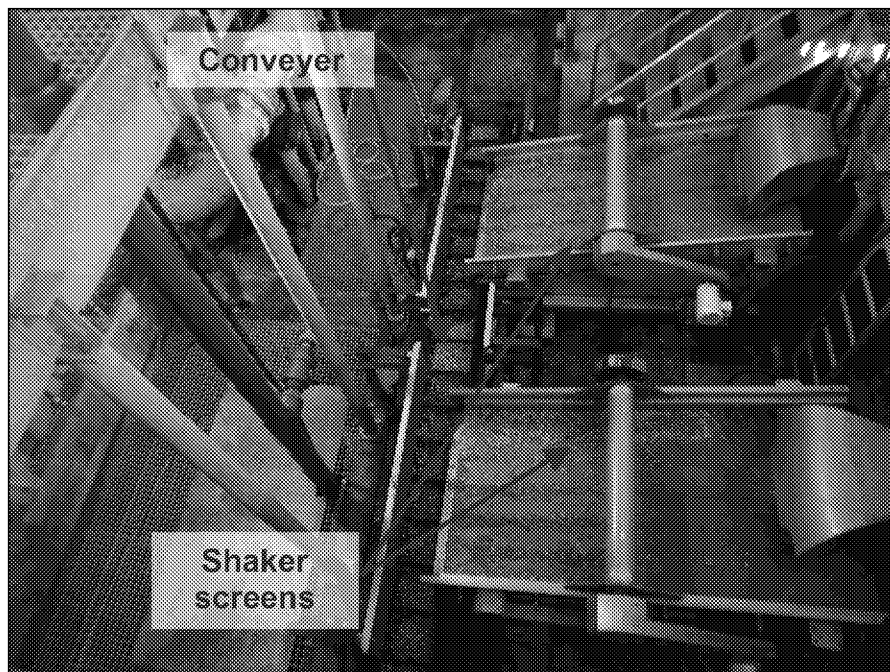
**Photograph 3.** View of the shaker screens and screenings conveyor inside the headworks building. Note that a significant amount of product is conveyed to the headworks along with process wastewater. Screenings are captured and stored at the solids storage pad.

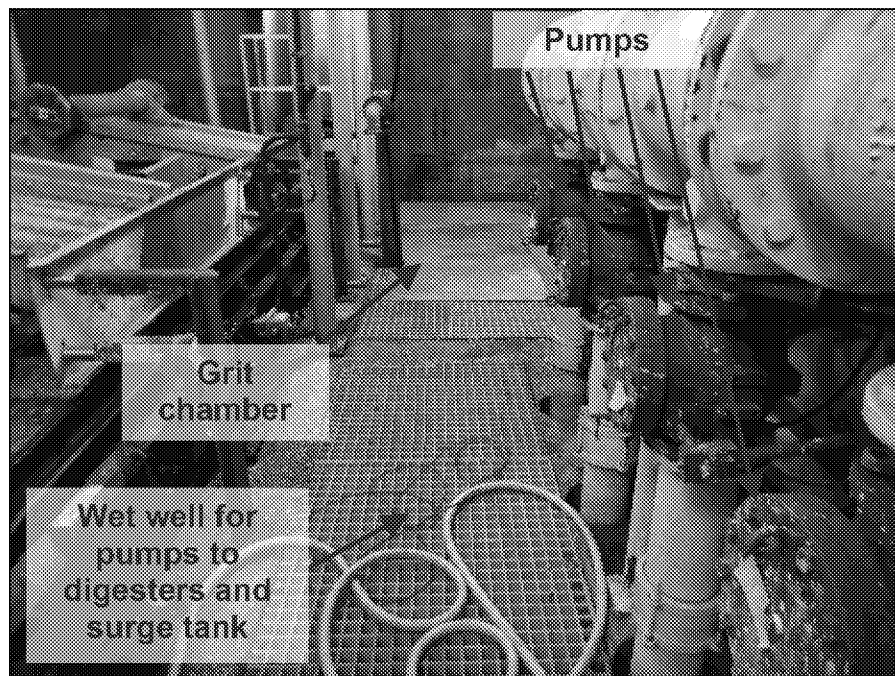
**Photograph 4.** View of the grit chamber and influent pumps wet well. Three pumps were installed to send flow to the digesters and one pump could be used for pumping wastewater to the surge tank if needed.

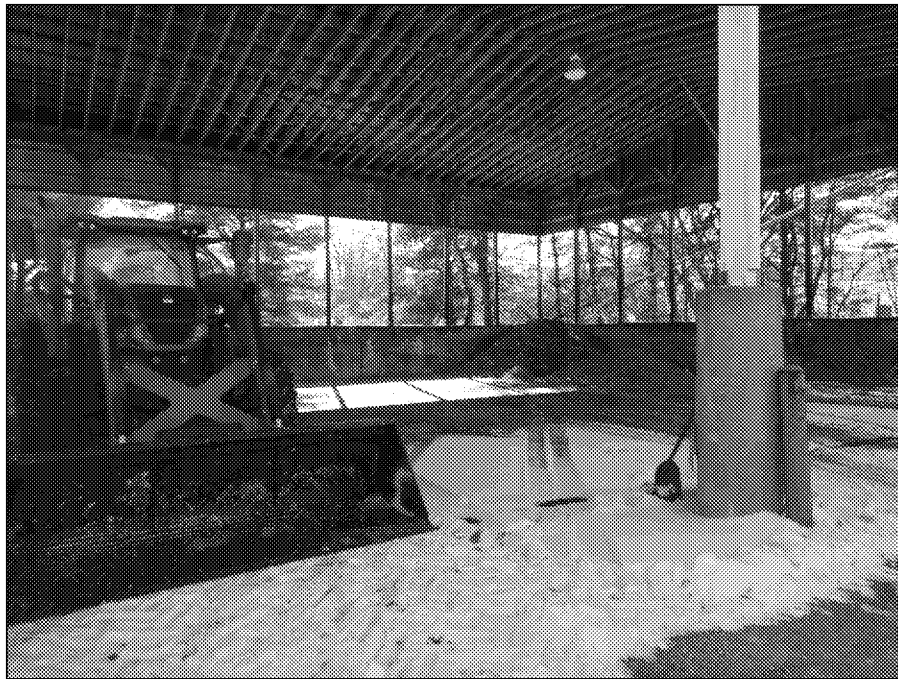
**Photograph 5.** View facing south of the solids storage pad in the eastern portion of the property. The pad was mostly empty at the time of the inspection.

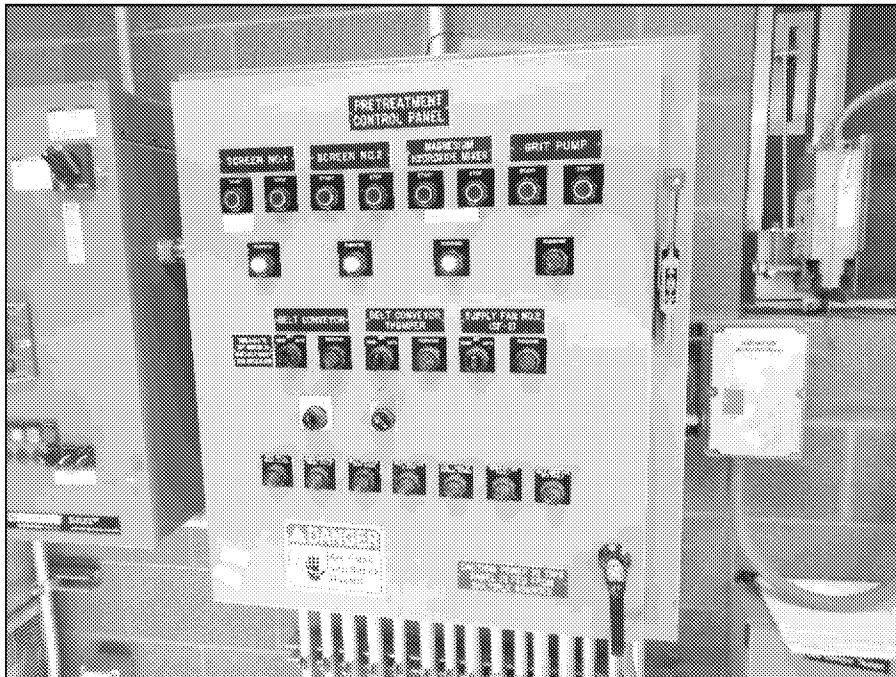
**Photograph 6.** View of the headworks control panel. Note that the shaker screens and MgOH mixer were running at the time of the inspection.

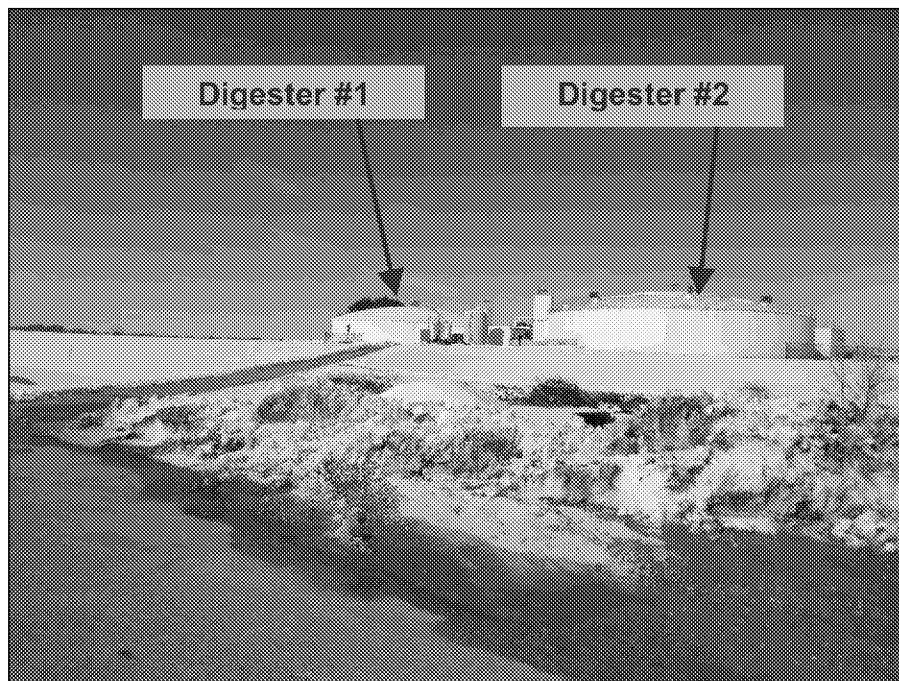
**Photograph 7.** View facing northwest of the anaerobic digesters.

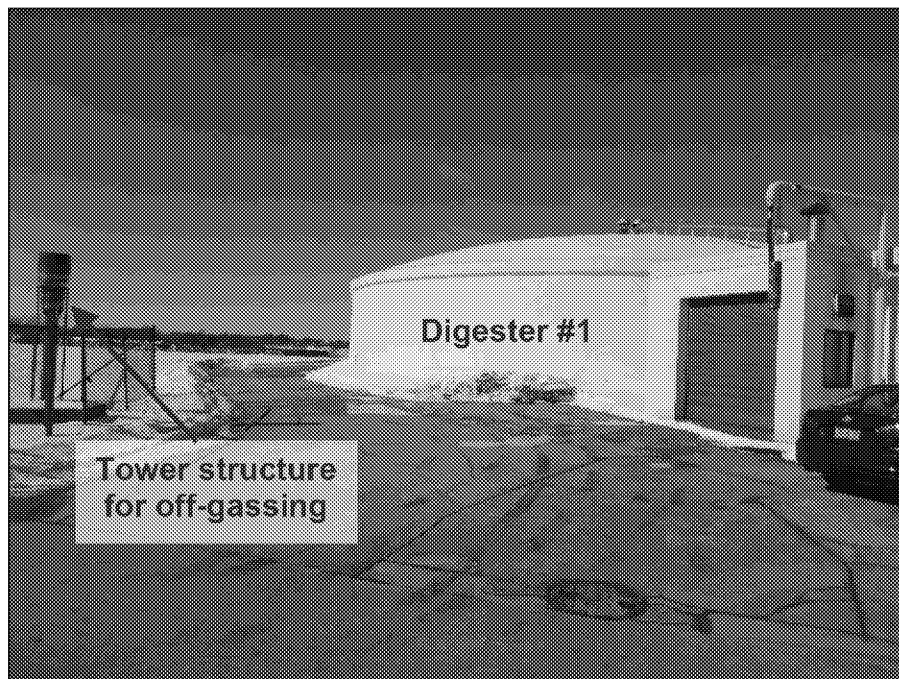
**Photograph 8.** View of facing northwest of digester #1.

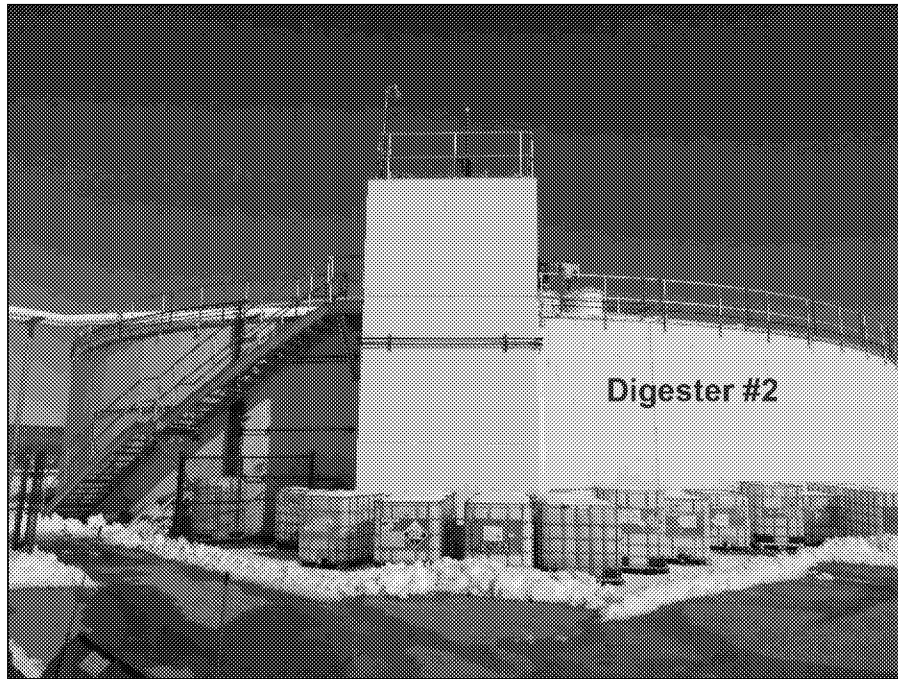
**Photograph 9.** View of facing northeast of Digester #2. Empty chemical totes were stored in front awaiting pickup.

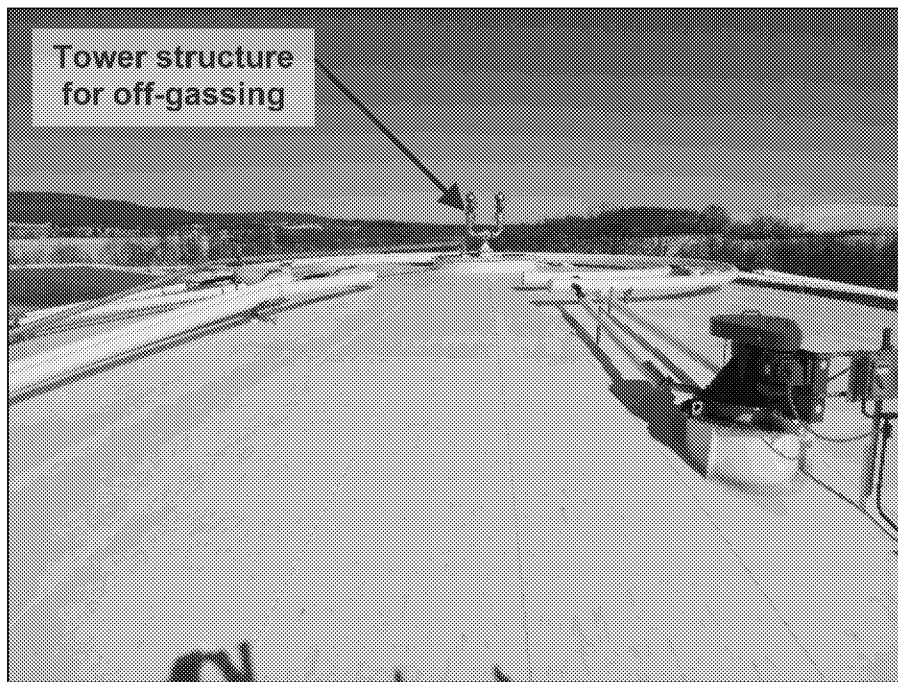
**Photograph 10.** View of the roof of Digester #2.

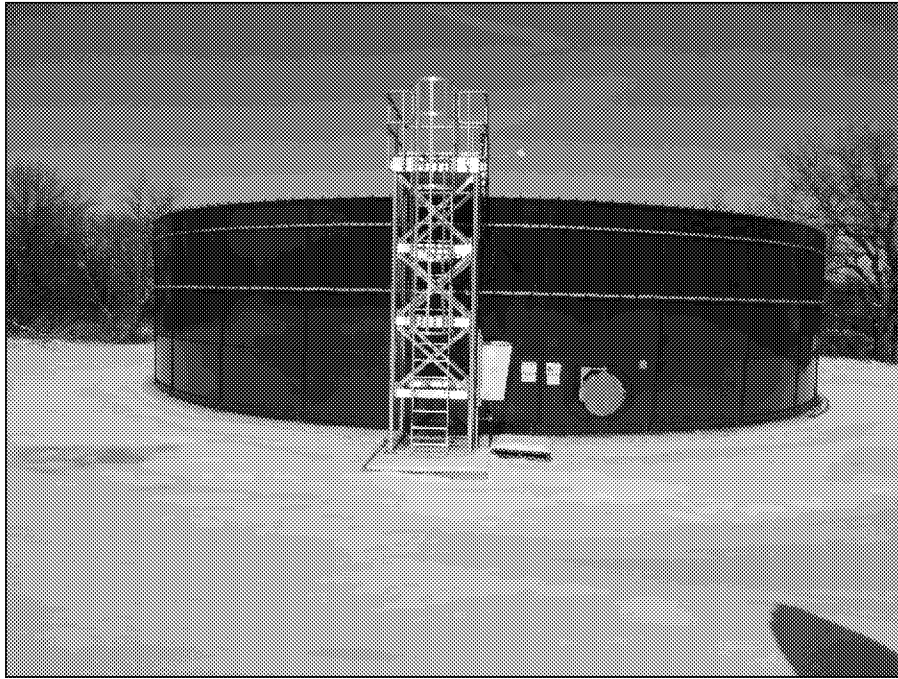
**Photograph 11.** View of 500,000-gallon surge tank.

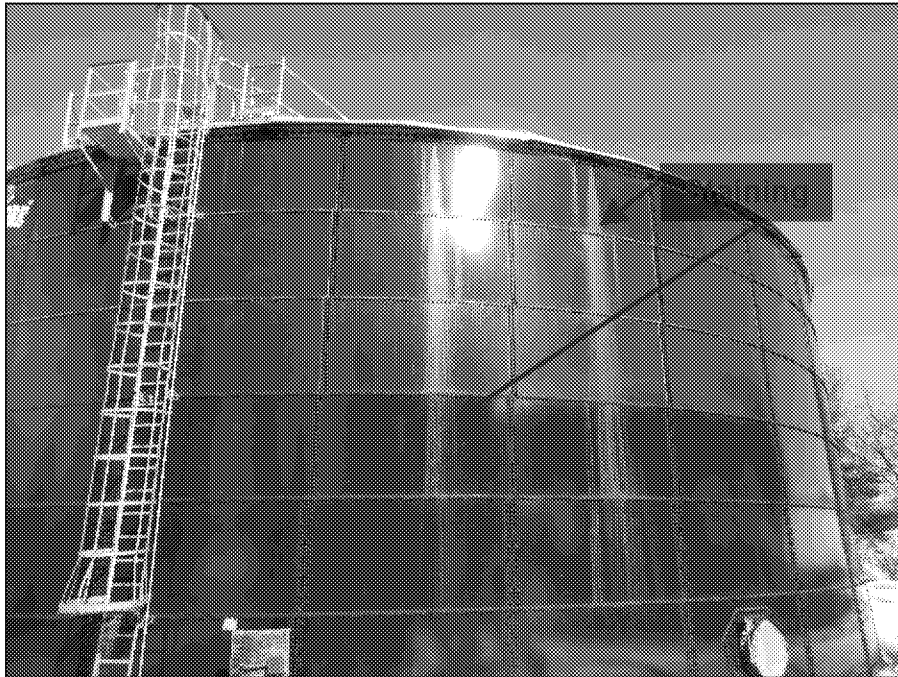
**Photograph 12.** View facing northeast of the slurry tank. Note brown staining down the sides.

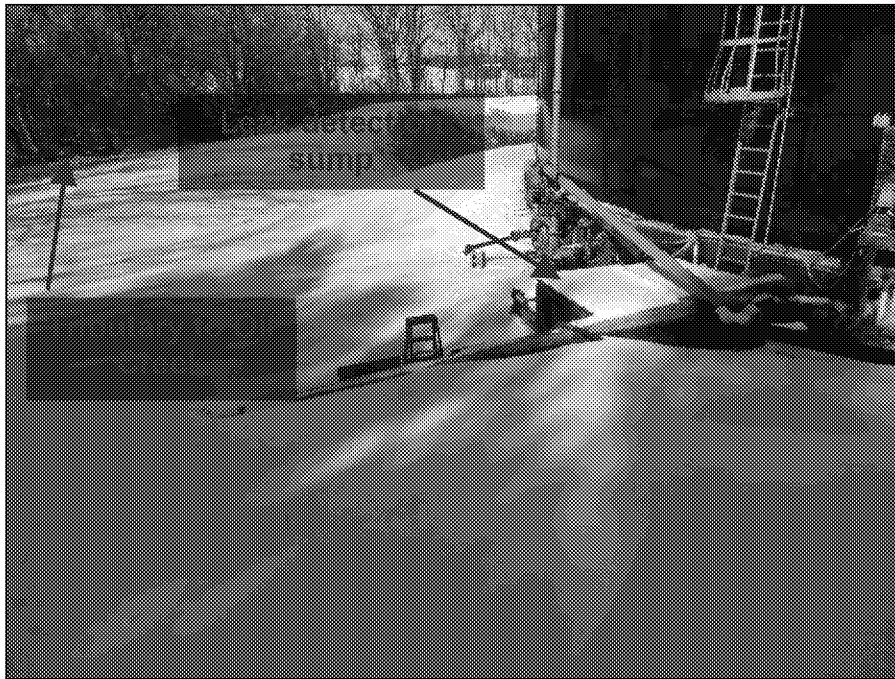
**Photograph 13.** Alternate view of the slurry tank. Note the leak detection sump and the proximity to the tributary to Oil Creek.

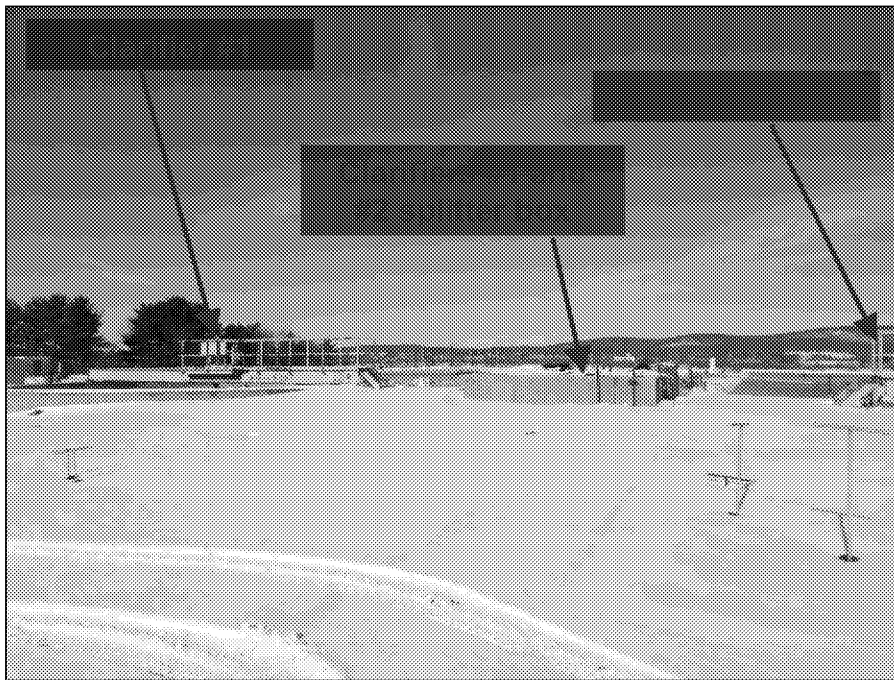
**Photograph 14.** View facing north of Clarifiers #1 and #2 and the clarifier splitter box for those units.

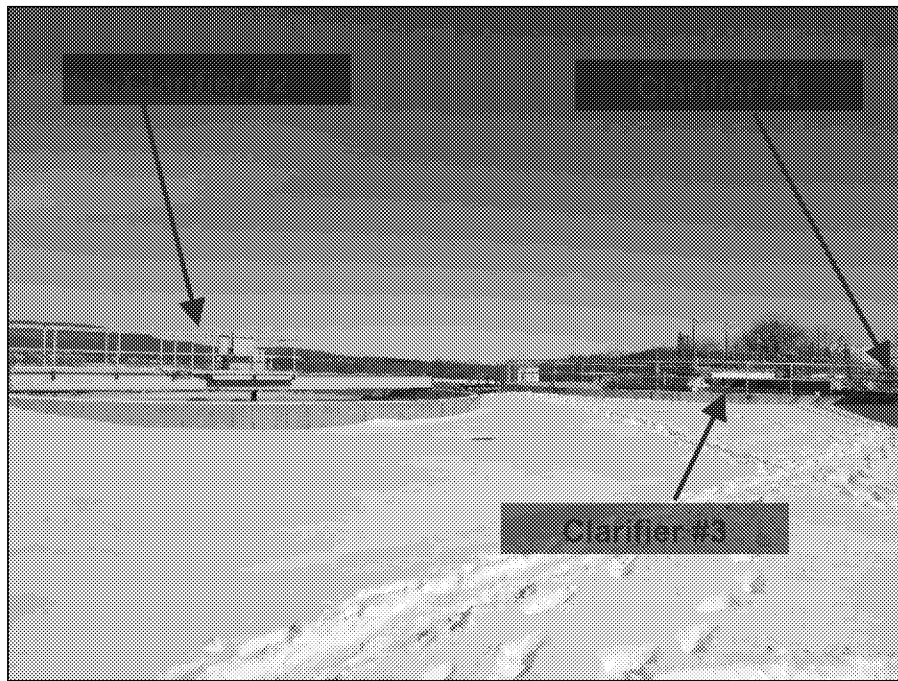
**Photograph 15.** View facing northeast of Clarifiers #2, #3, and #4.

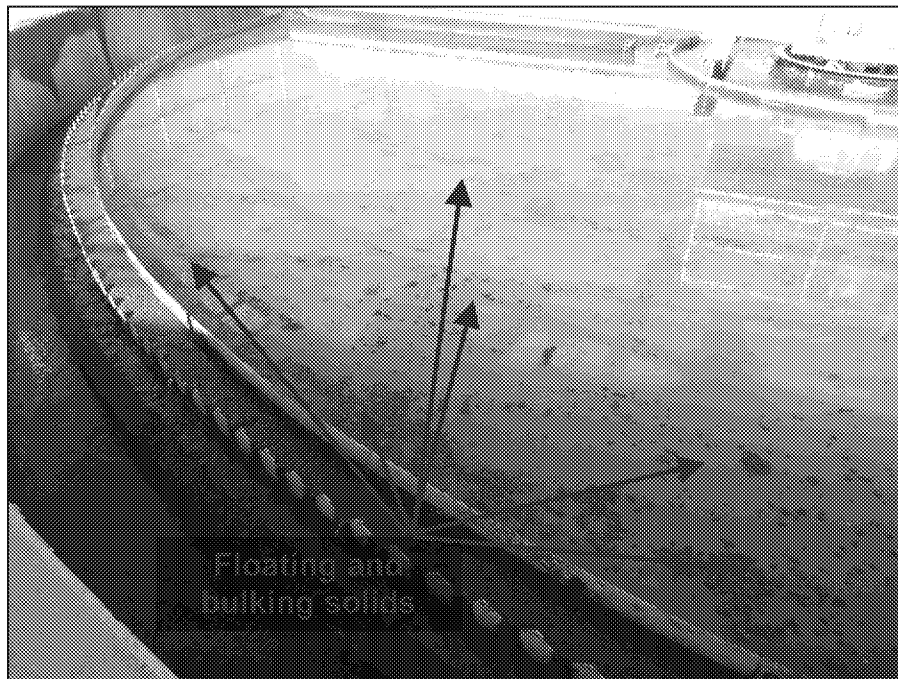
**Photograph 16.** View of Clarifier #3. Note that a significant amount of floating and bulking solids was observed.

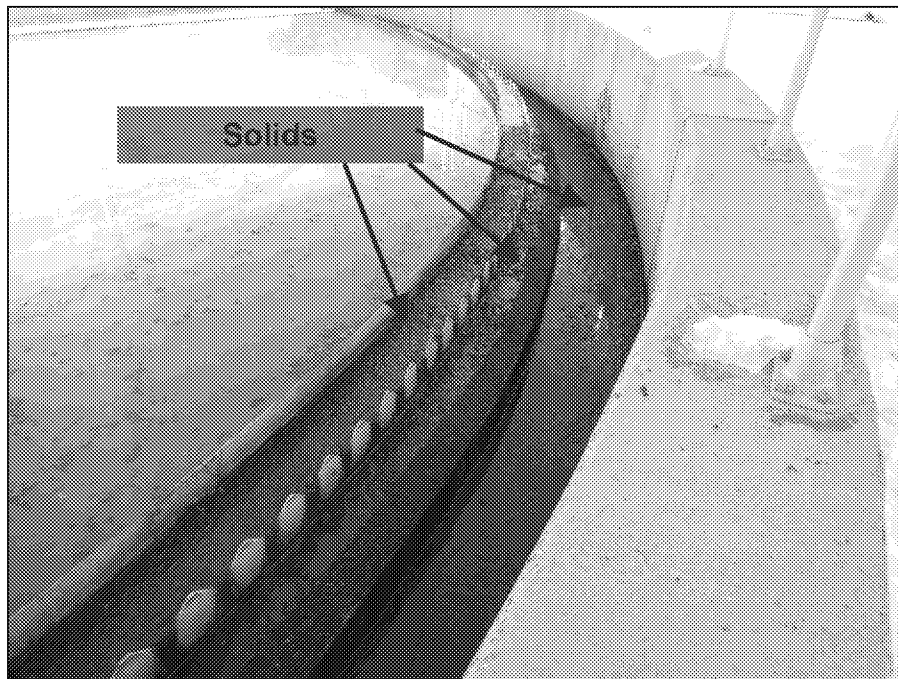
**Photograph 17.** View of solids on both sides of the Clarifier #3 weir and in the effluent trough.

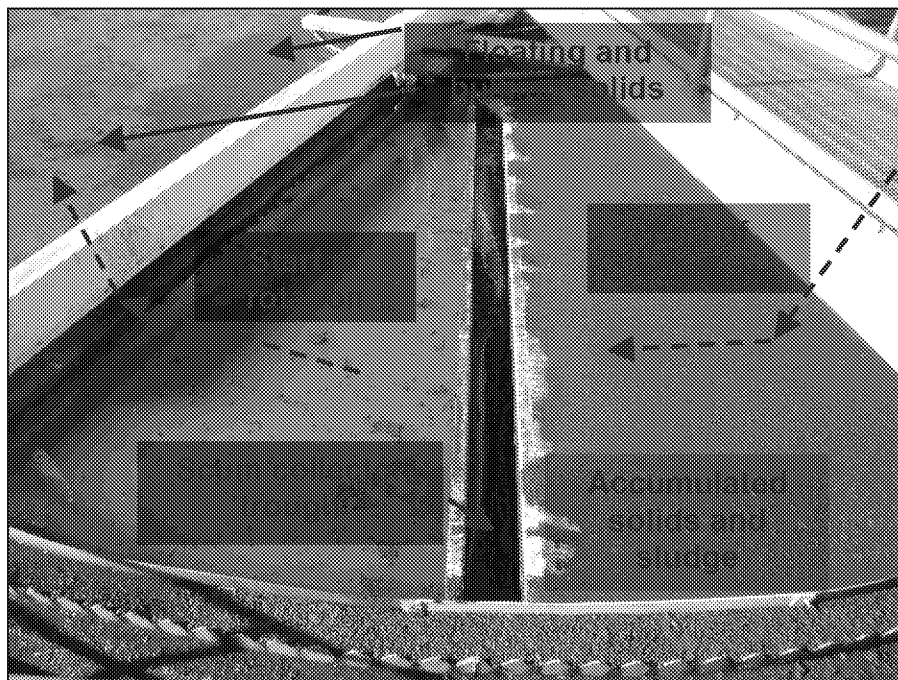
**Photograph 18.** Additional view of Clarifier #3. Note the floating and bulking solids at the beginning of the skimmer arm rotation and the thick accumulated solids and sludge at the end of the rotation.

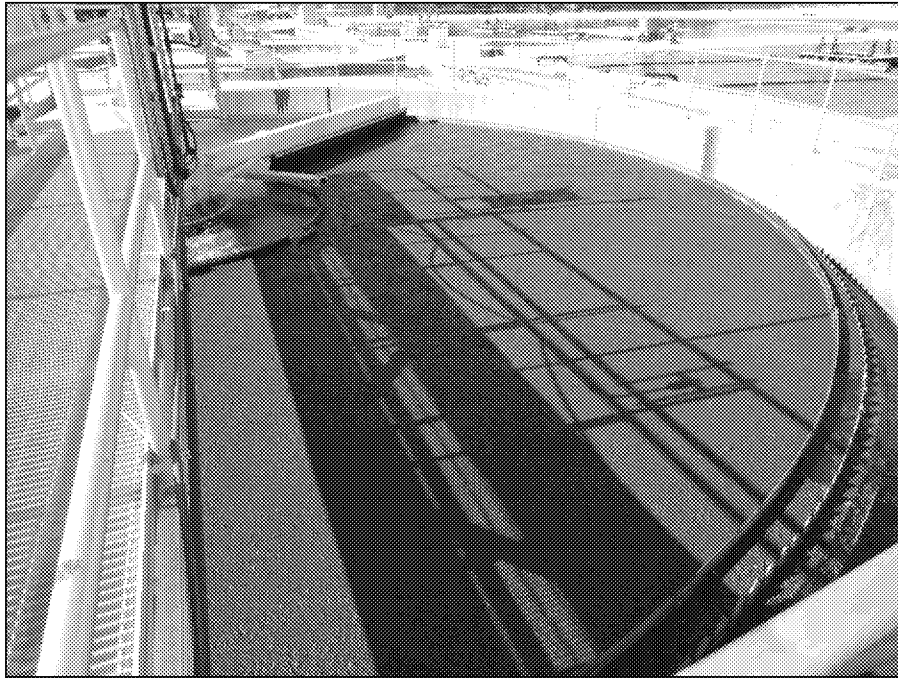
**Photograph 19.** View of Clarifier #3, near the end of the skimmer arm rotation. Note the dense accumulation of solids and sludge in the tank.

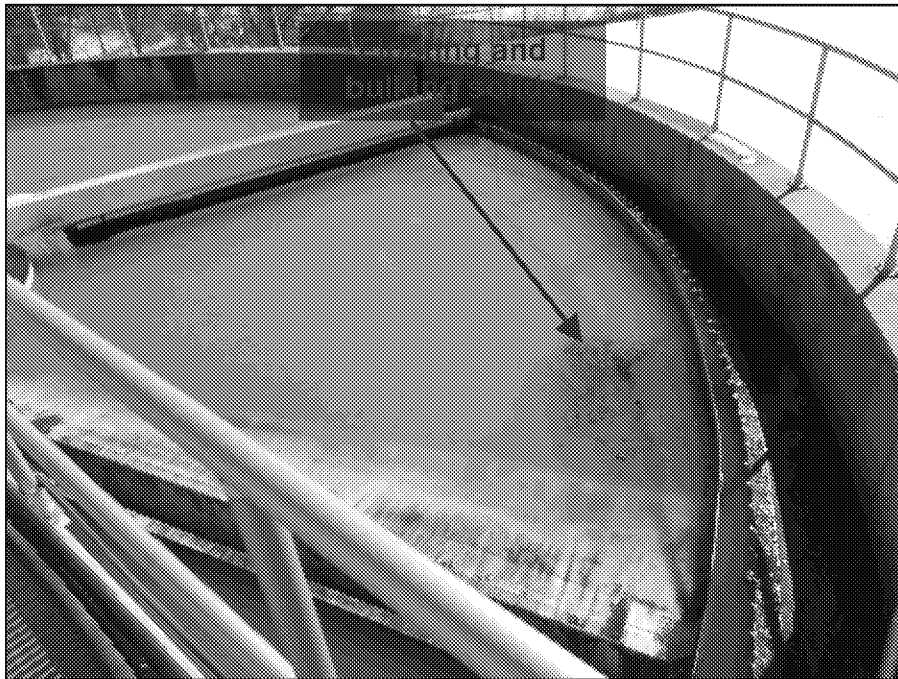
**Photograph 20.** View of floating and bulking solids in Clarifier #4.

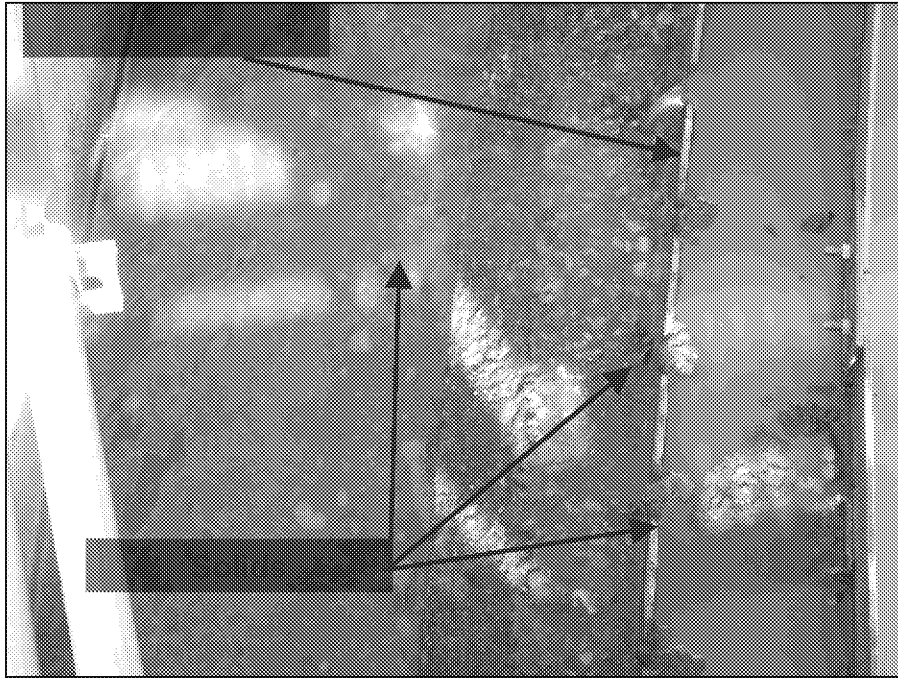
**Photograph 21.** View of solids flowing over the weir in Clarifier #4.

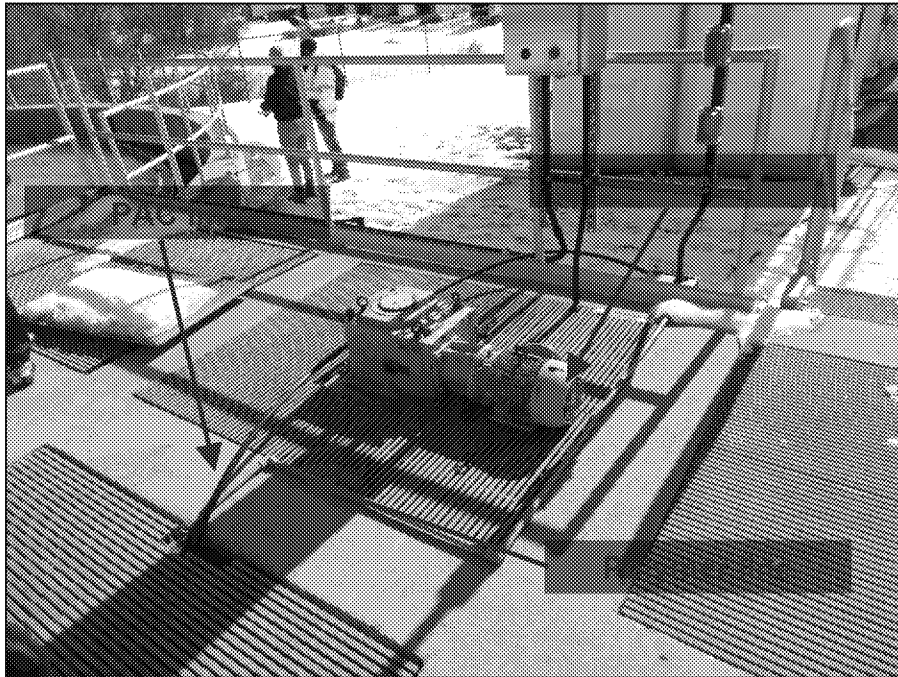
**Photograph 22.** View of the Clarifiers #3 and #4 splitter box where PAC and polymer are added and mixed.

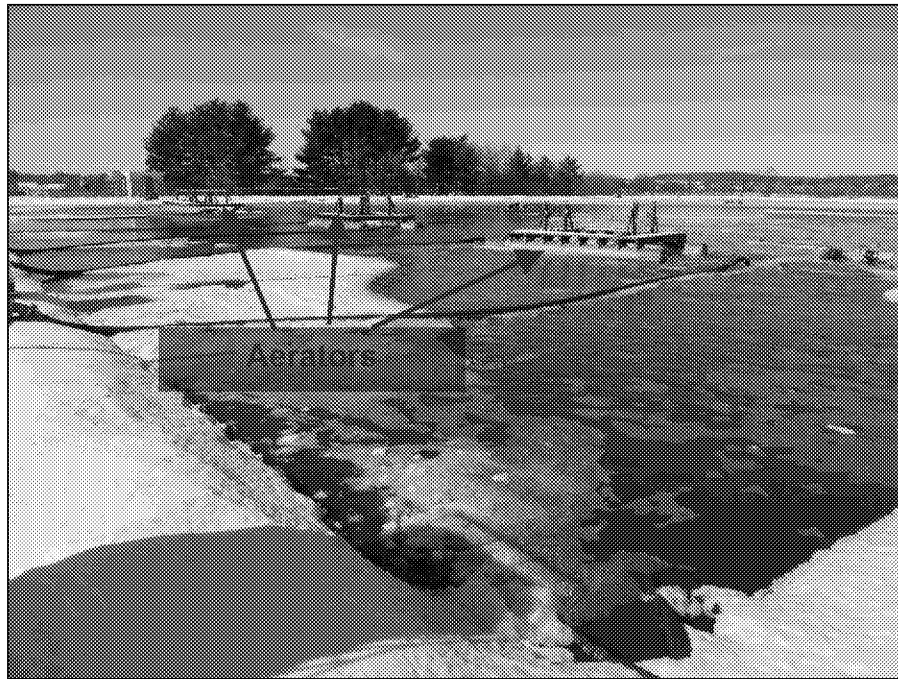
**Photograph 23.** View facing northwest of barge aerators in Lagoon #1.

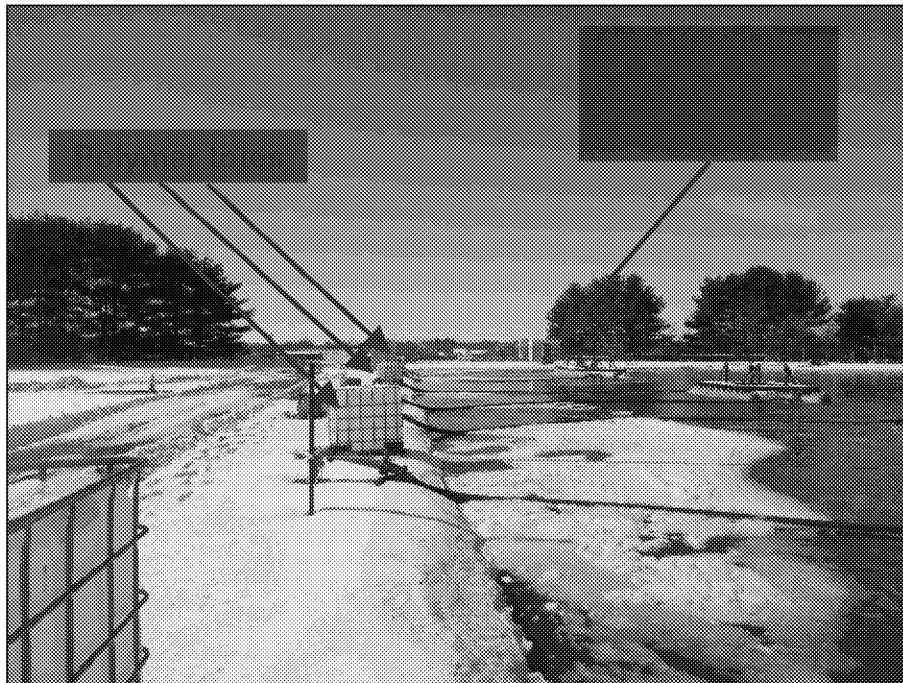
**Photograph 24.** View facing west of totes used for polymer addition at the south end of Lagoon #1.

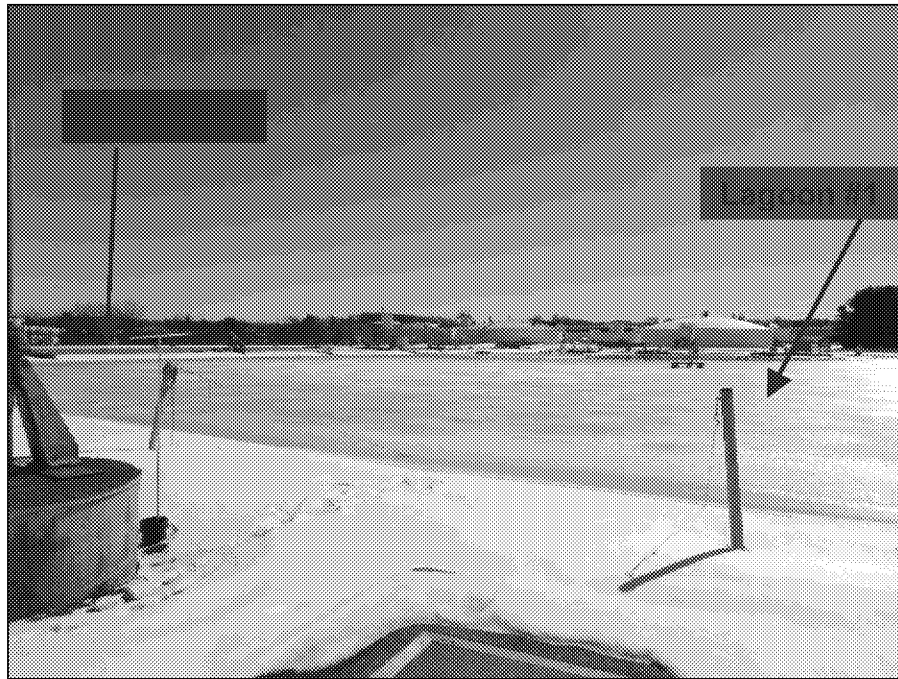
**Photograph 25.** View facing south of north end of Lagoon #1. Note that this area of the lagoon was frozen at the time of the inspection.

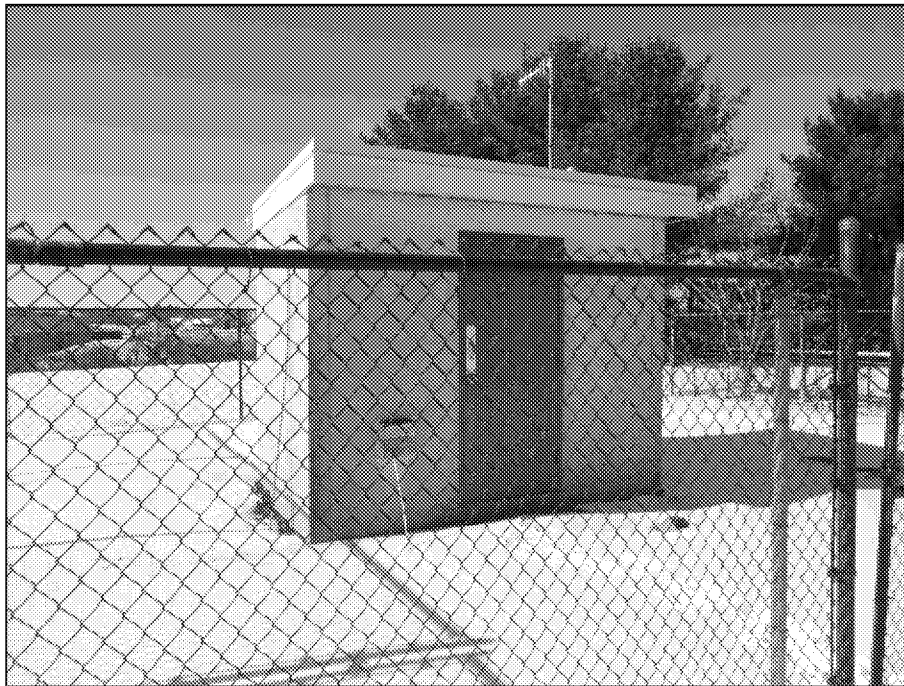
**Photograph 26.** View of the pump house used for monitoring and directing flow to the Penn Township WWTP.

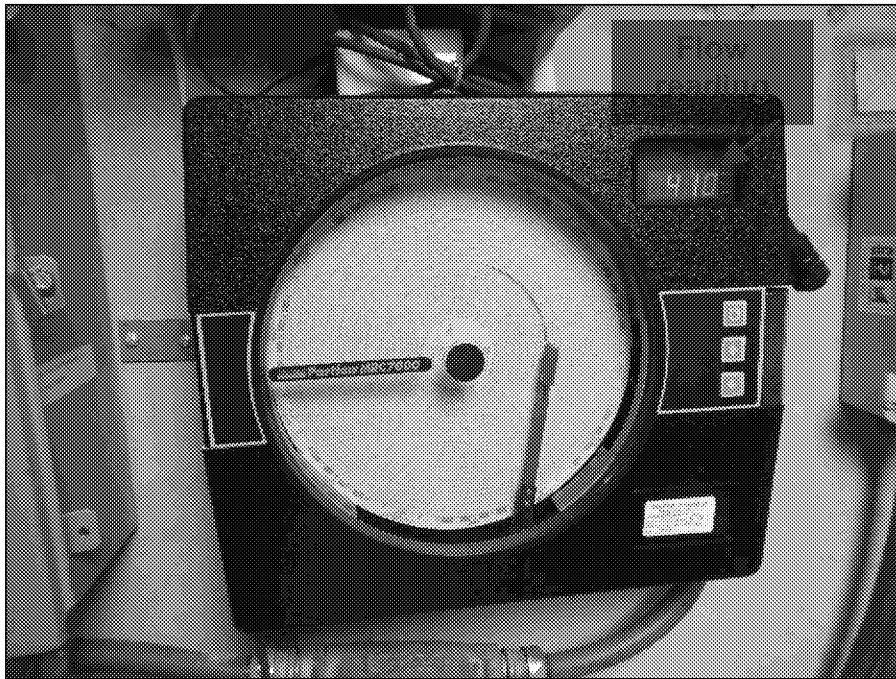
**Photograph 27.** View of the flow meter in the pump house shown in Photograph 26. The Facility was pumping pretreated industrial wastewater to Penn Township at a rate of approximately 410,000 gallons per day at 12:18 p.m. on the day of the inspection.

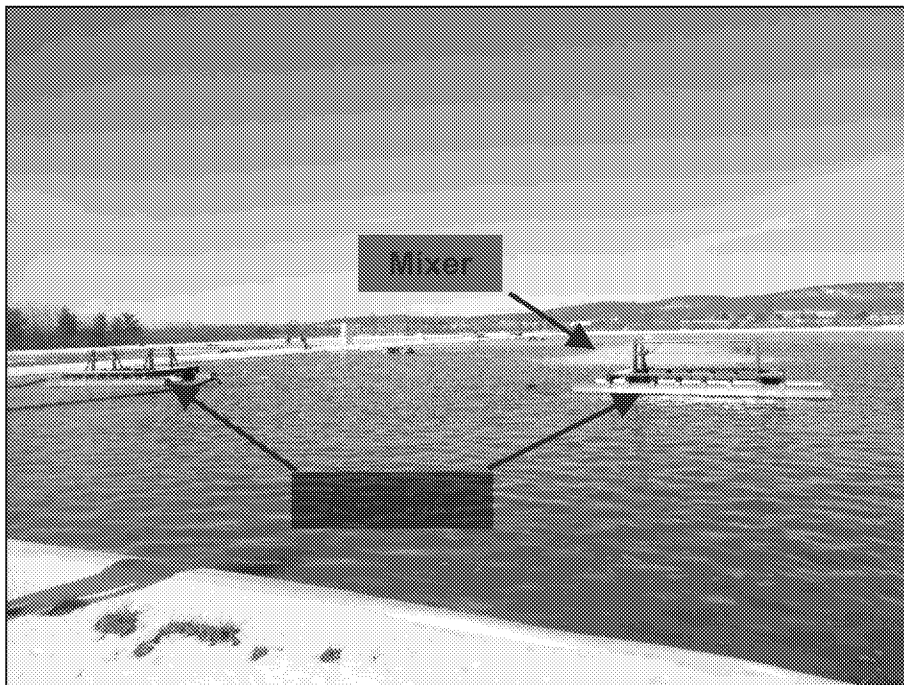
**Photograph 28.** View facing northwest of Lagoon #2.

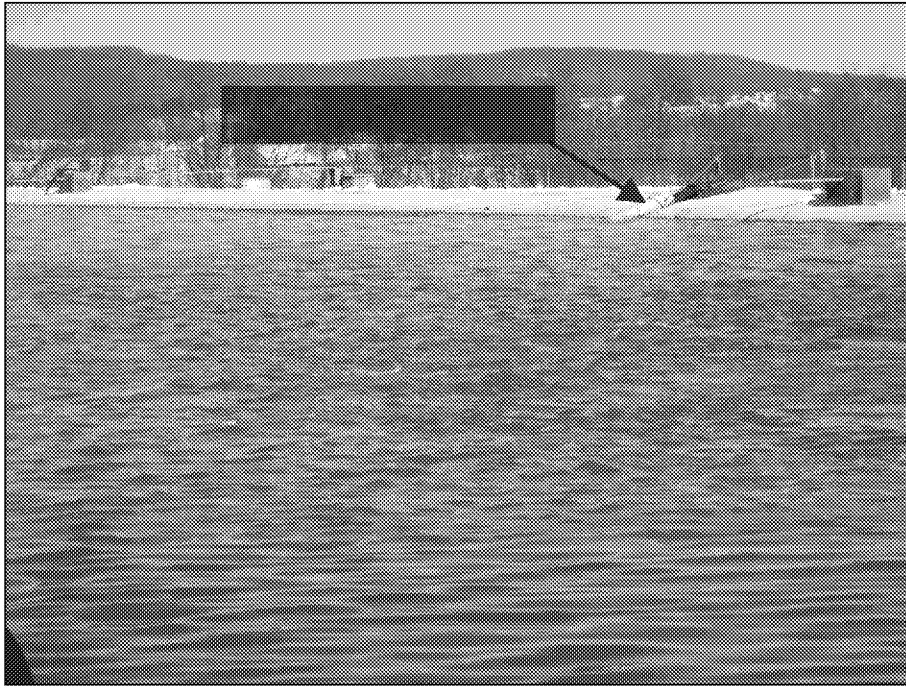
**Photograph 29.** View facing northeast of the cooling water line coming into the east perimeter of Lagoon #2.

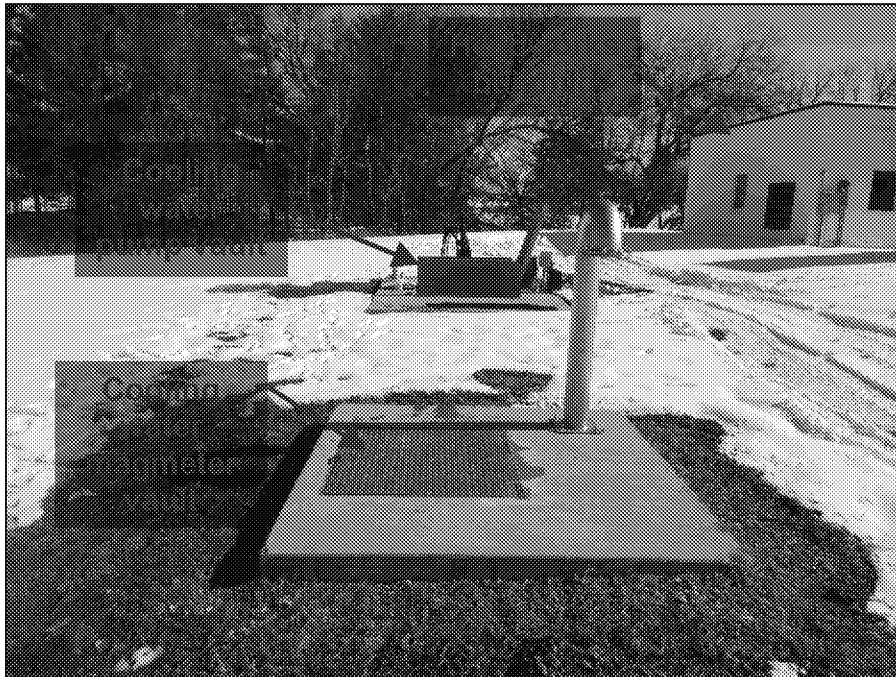
**Photograph 30.** View of the cooling water pump and magmeter vaults, located close to the WWTF headworks building.

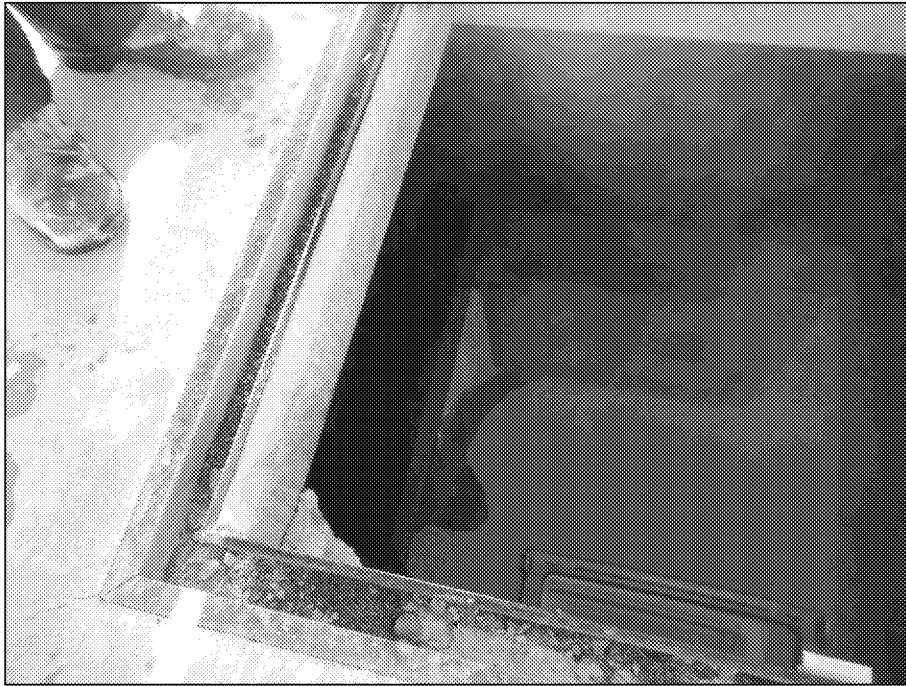
**Photograph 31.** View inside the cooling water magnetometer vault. Note that the vault was flooded, and the surface of the water was steaming.

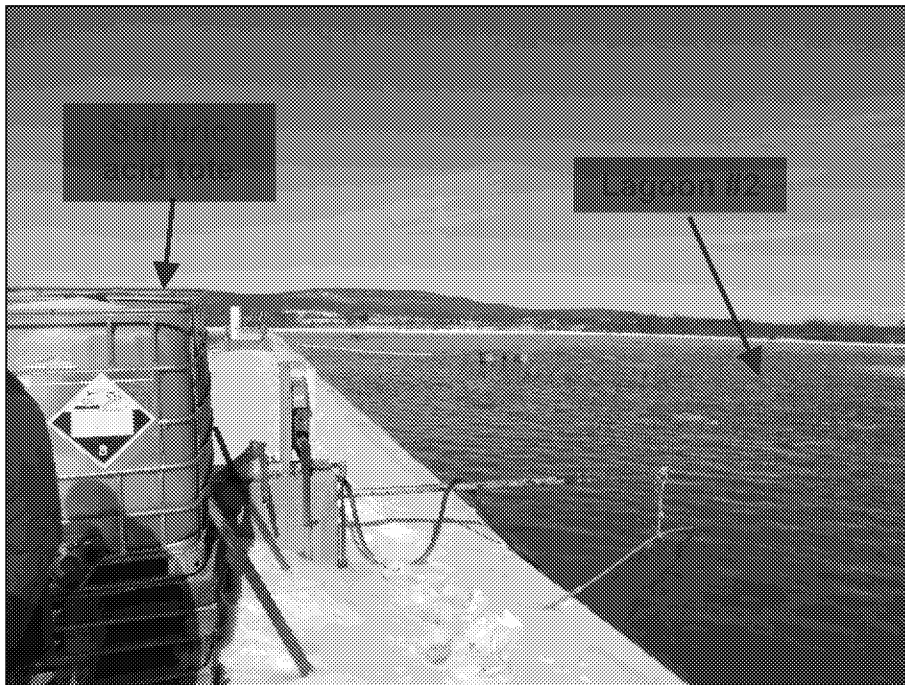
**Photograph 32.** View of the sulfuric acid tote used to help control pH in Lagoon #2.

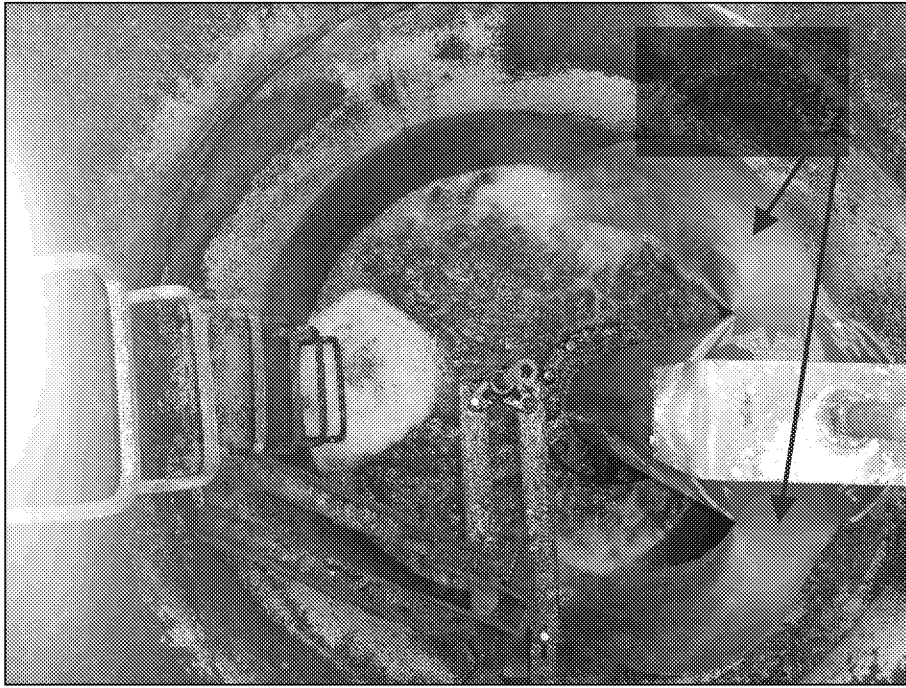
**Photograph 33.** View inside the effluent discharge riser for Lagoon #2. Note that the effluent appeared turbid.

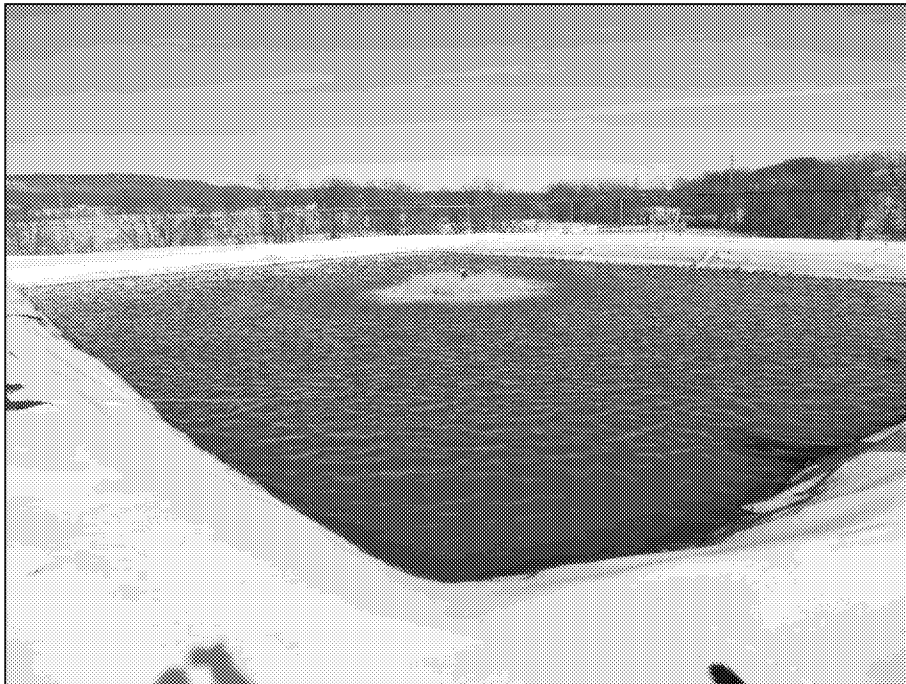
**Photograph 34.** View Polishing Pond #1.

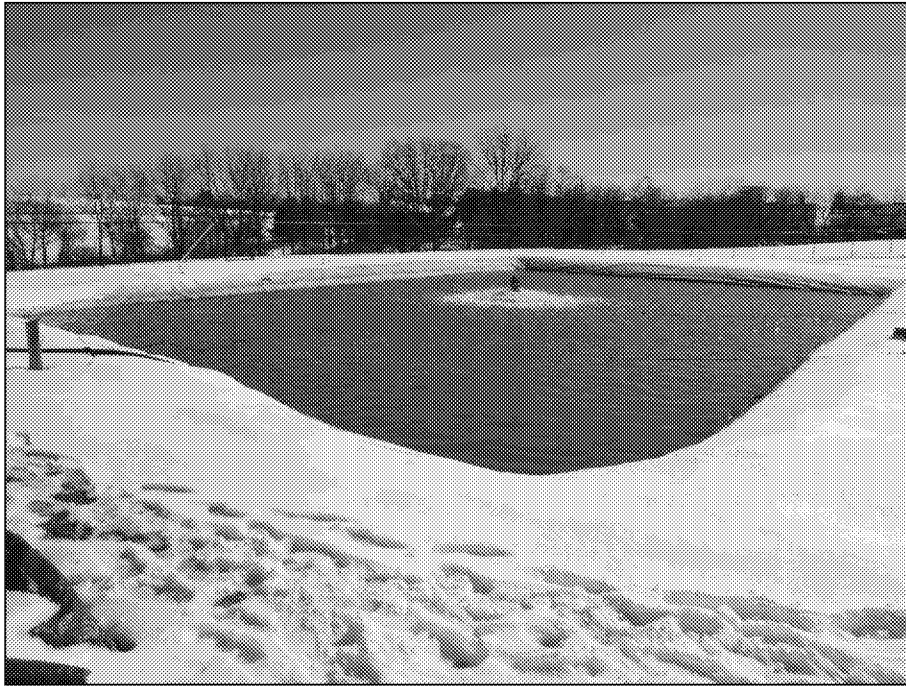
**Photograph 35.** View of Polishing Pond #2.

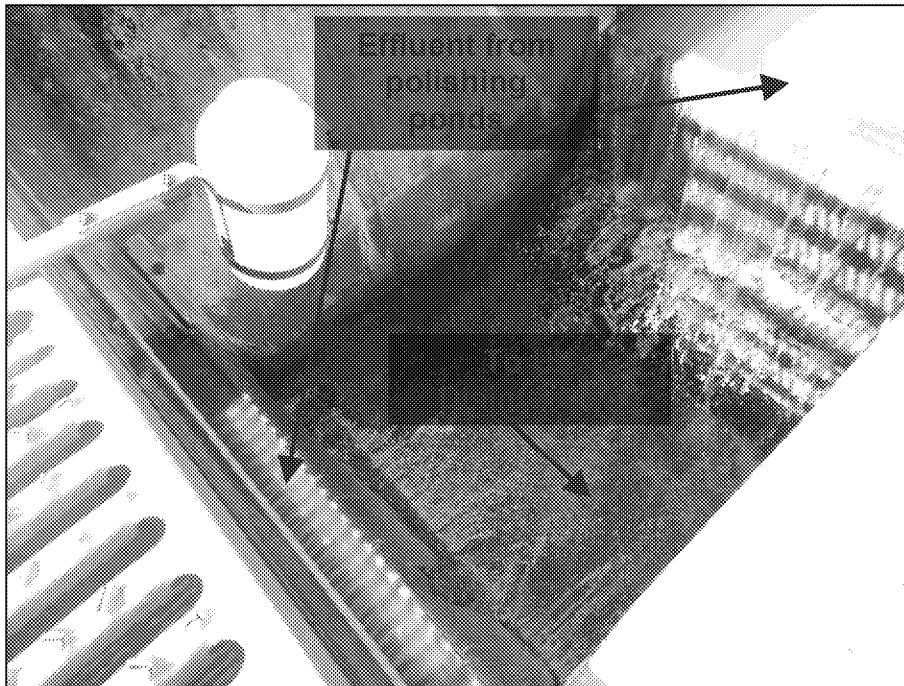
**Photograph 36.** View the polishing ponds effluent chamber. Note that the effluent appeared turbid.

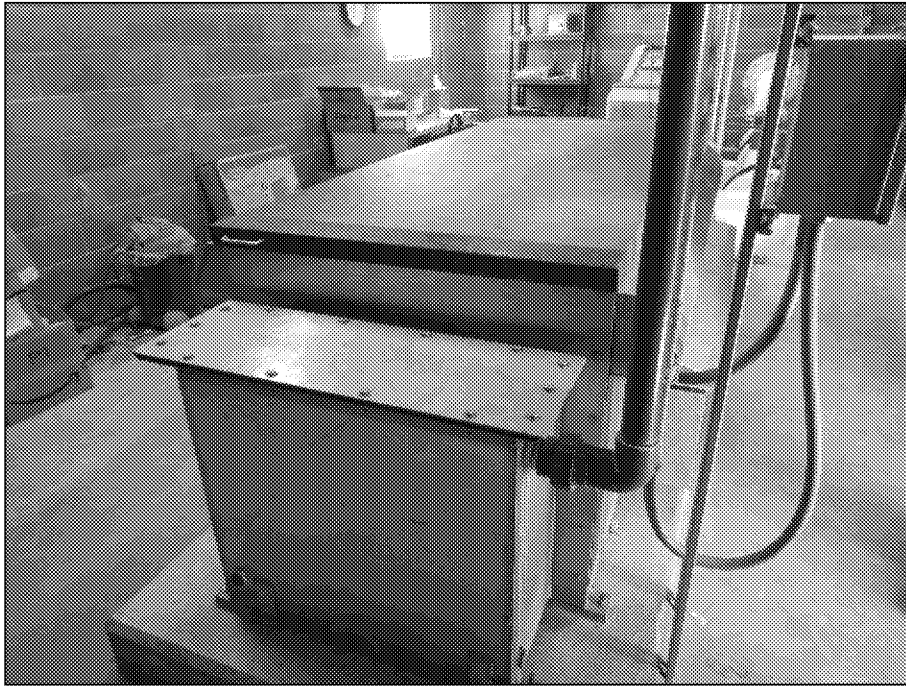
**Photograph 37.** View of the UV disinfection system.
